Technical Service Information Bulletin

EVAP SYSTEM DIAGNOSIS: P0441 / P0446

ES 300, SC 400, LS 400, LX 450

ENGINE
EG001-98

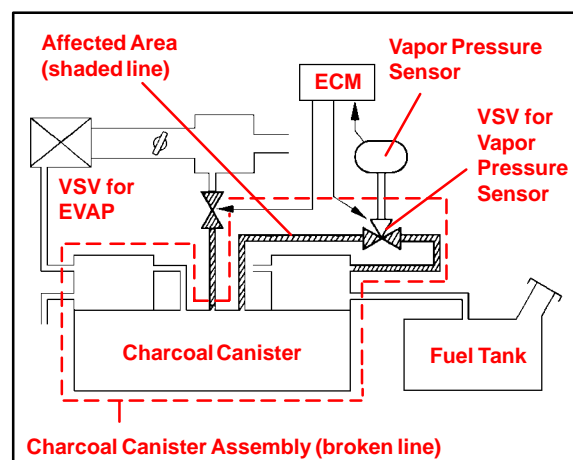
When performing diagnostics for an occurrence of a MIL "ON" condition, the Diagnostic Trouble Code (DTC) P0441 may be the result of debris in the Evaporative Emission Control System. This may cause blockage of a vapor line, or a stuck VSV, as described in the troubleshooting area of the Repair Manual.

1. Inspect vacuum hoses and pipes between EVAP (Purge) VSV and Charcoal Canister for leaks.
2. Replace Vapor Pressure VSV and Canister.
