TECHNICAL SERVICE INFORMATION

REF: ENGINE
NO: EG004-96
DATE: OCTOBER 11, 1996
MODEL: ALL MODELS

Title **UNDERCOATING ON OXYGEN SENSORS**

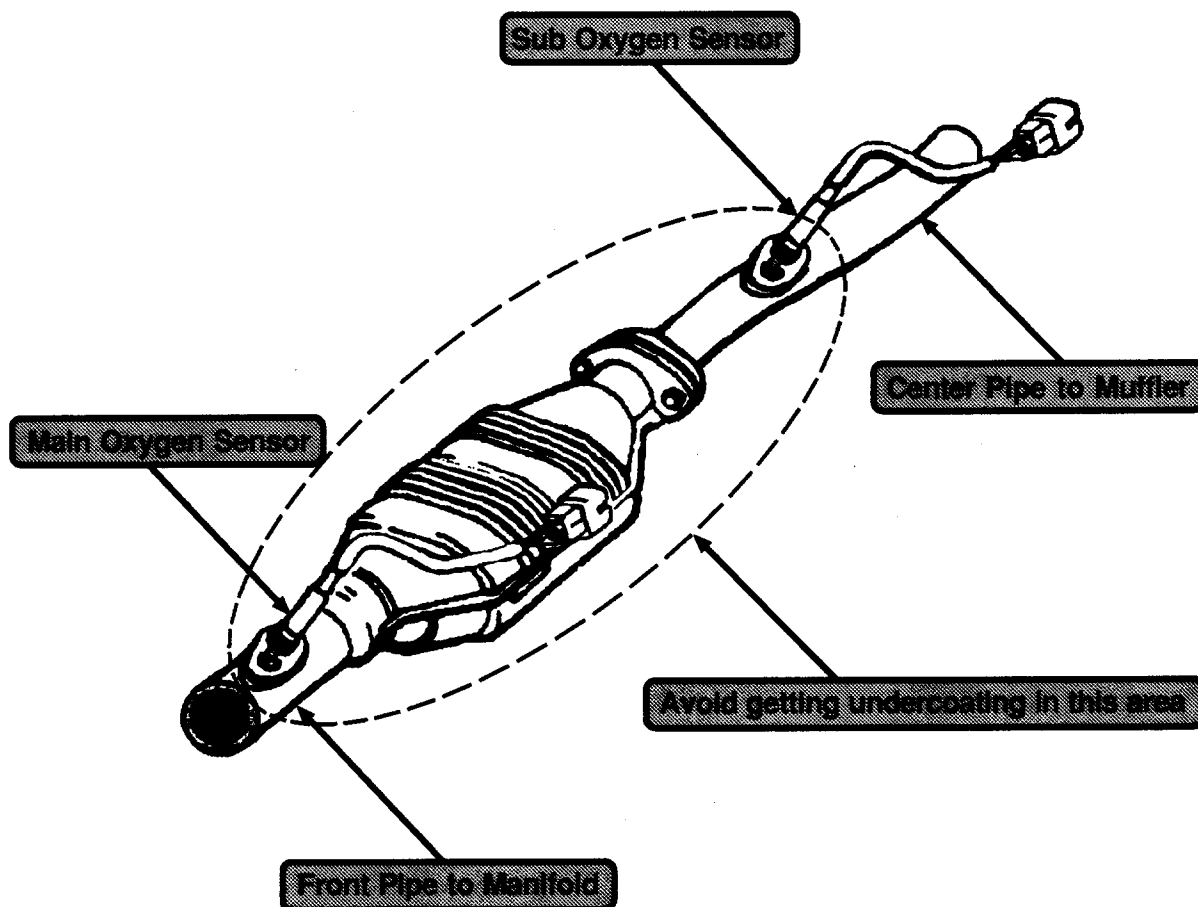
During vehicle processing by Dealers, care must be taken to avoid applying undercoating in the area surrounding the Oxygen Sensors. Application of undercoating on or near the Oxygen Sensors can cause insufficient air to flow around the sensor, and inaccurate information storage by the ECM. If this condition occurs, the Malfunction Indicator Light (MIL) may illuminate.
