## Technical Service BULLETIN

### TRAILER WIRE HARNESS

**4Runner, Highlander, Land Cruiser, RAV4,  
Sienna, Tacoma & Tundra**

AX006-02

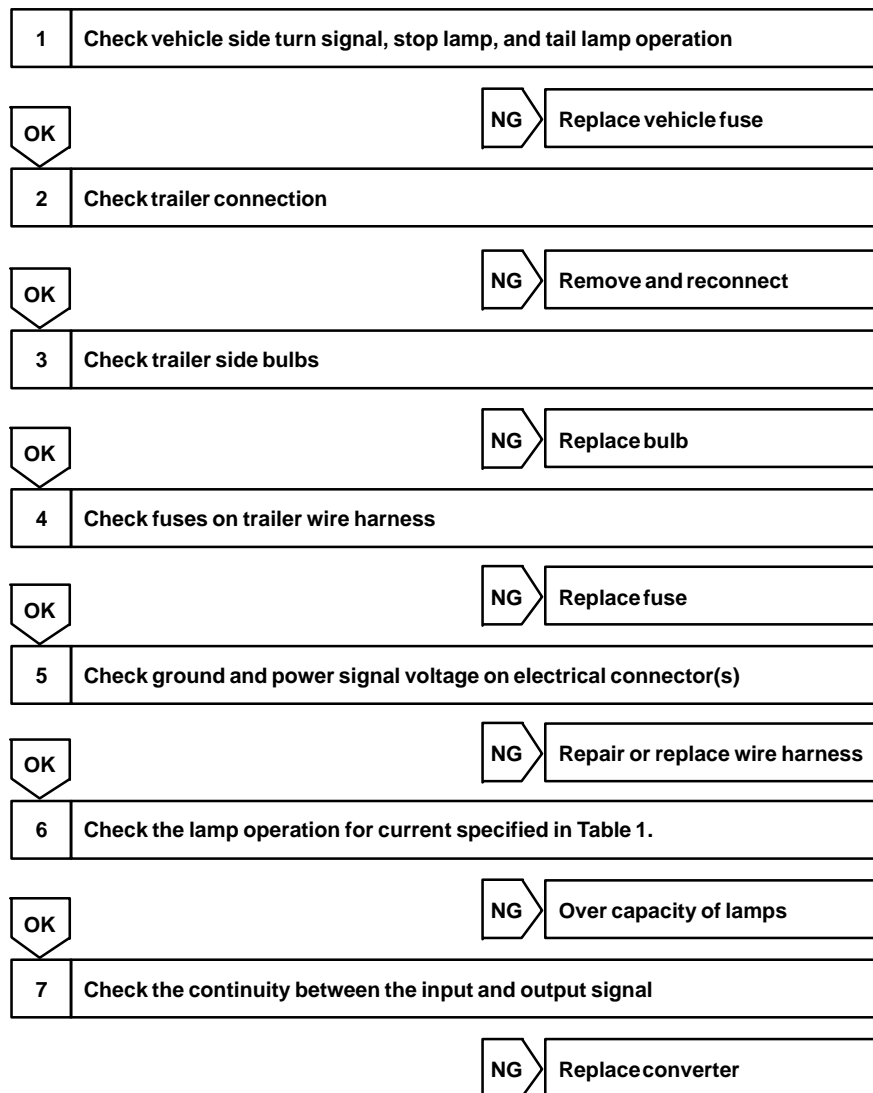
**Troubleshooting Chart 1: Land Cruiser ('00), RAV4, Sienna, & Tacoma**

Perform the following procedure if there is any lamp malfunction.

MODEL	RATED CURRENT	
RAV4, Sienna, Tacoma	TAIL	MAX 3.5A
	STOP/TURN (RIGHT)	MAX 2.1A
	STOP/TURN (LEFT)	MAX 2.1A
Land Cruiser ('00)	TAIL	MAX 5.5A
	STOP/TURN (RIGHT)	MAX 4.2A
	STOP/TURN (LEFT)	MAX 4.2A

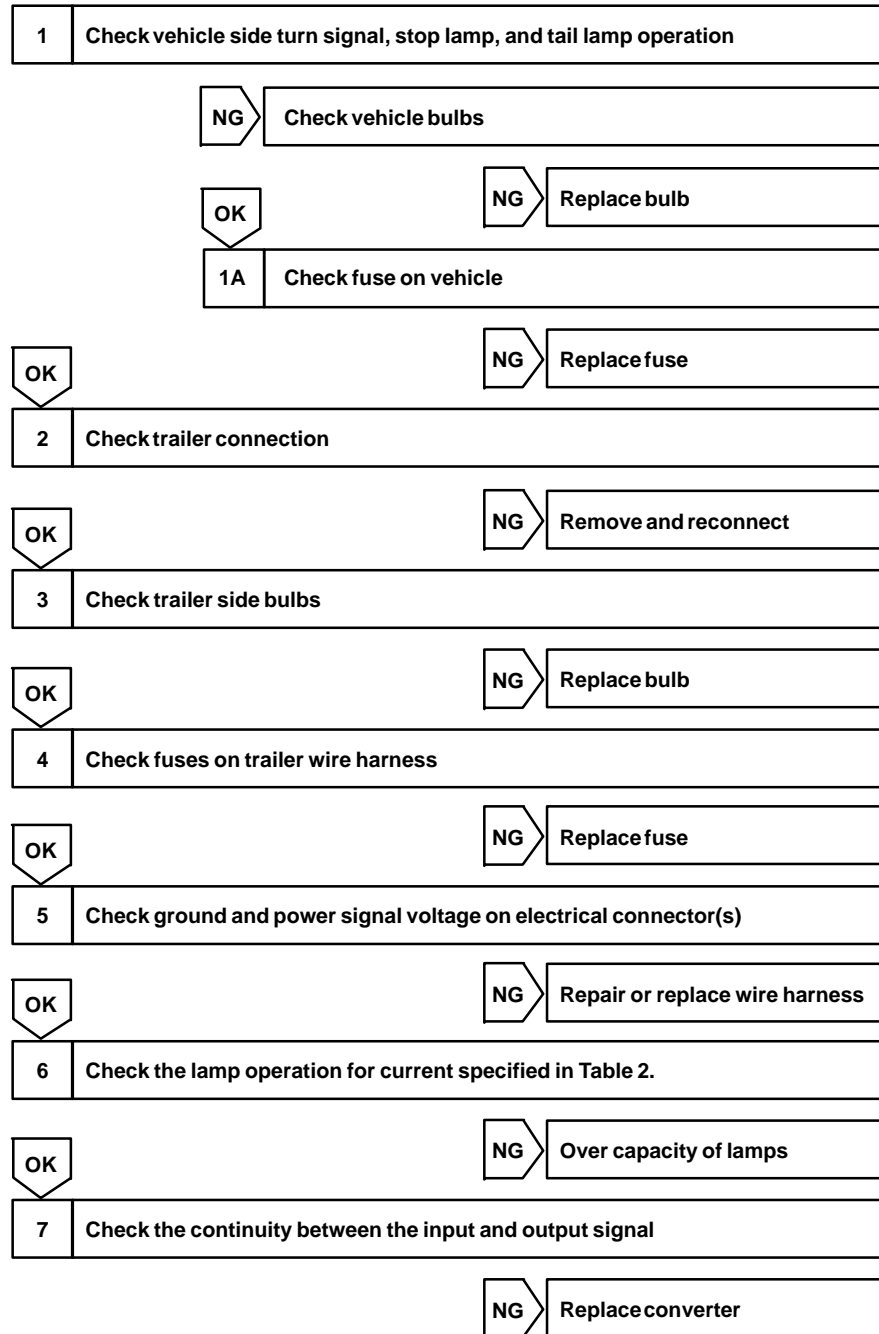
**Troubleshooting Chart 2: 4Runner, Highlander, Land Cruiser ('01-'02), & Tundra**

Perform the following procedure if there is any lamp malfunction.

MODEL	RATED CURRENT	
4Runner, Highlander, Land Cruiser ('01-'02), Tundra	TAIL	MAX 7.8A
	STOP/TURN (RIGHT)	MAX 4.5A
	STOP/TURN (LEFT)	MAX 4.5A
