# TOYOTA

# TECHNICAL SERVICE BULLETIN

NO.: BO007-96

## FRONT DOOR BELT MOLDING WIND NOISE

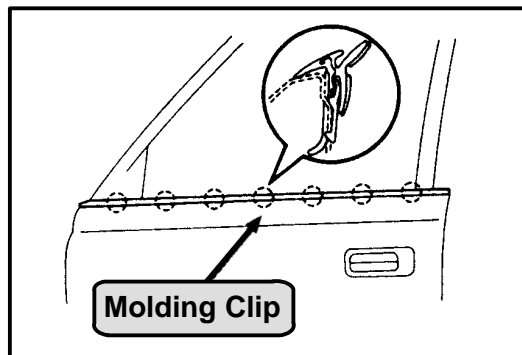
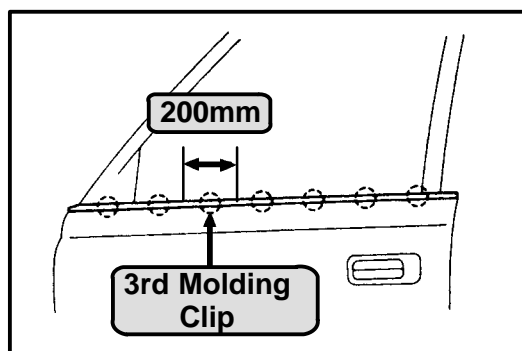
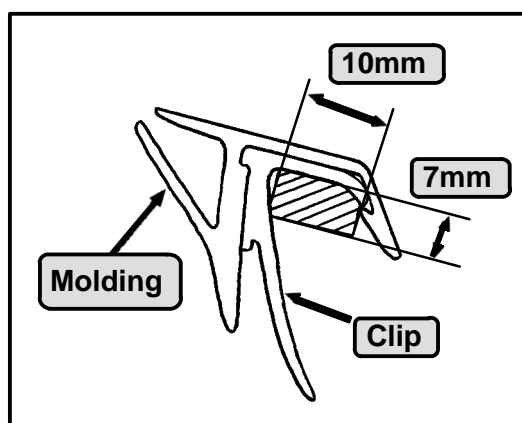
To prevent a high pitch wind flutter noise caused by air rushing between the front door belt molding and outer door skin area, foam-backed tape has been added to the back side of the molding.

- **Center** and adhere a piece of foam backed tape (from the Toyota Squeak and Rattle Kit, P/N 08231-00801) to the back side of the molding, directly over the third clip (3rd clip counting from the front edge of the molding).

**NOTE:** Tape should be approximately 10 mm wide X 7 mm thick X 200 mm long.

- Reinstall belt molding (be sure that all attaching clips are properly lined-up with corresponding holes in the door panel before attempting to install the molding).
- Install screw at rear edge of belt molding.
- Install outside mirror to body with 3 attaching screws and snap lower frame bracket garnish (triangular plastic mirror base) back into place.
- Road test vehicle to confirm elimination of wind noise condition.
