Technical Service Information Bulletin

CIGARETTE LIGHTER SERVICE

ELECTRICAL
EL005-98

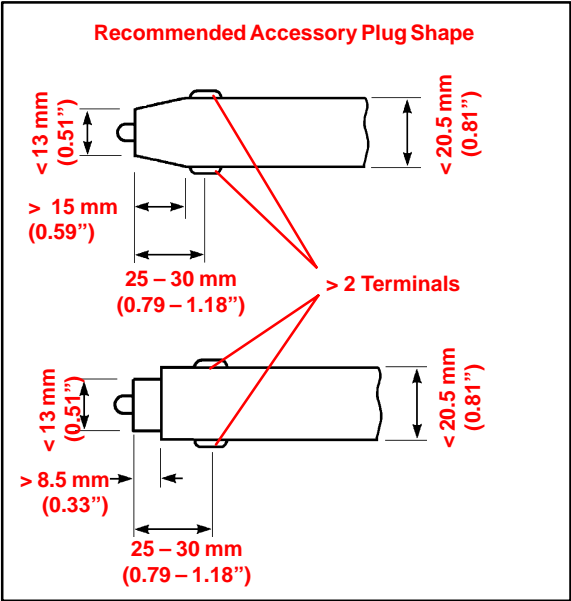
2. If the lighter element is original equipment and the lighter socket is bent or pulled out of the dash, please ask the customer about the accessory plug being used in the lighter socket.
- a. The attached specifications in the drawing provide the maximum recommended size of accessory plug. If the customer is using an accessory plug larger than recommended, please advise the customer to use a plug of appropriate size.

b. Using a power plug larger than the given dimensions may damage the lighter socket.

c. If the vehicle has a power point socket, advise the customer to use this socket instead of the lighter socket.
