## Technical Service Information

Title **DOM FUSE INSTALLATION DURING PDS ON LX 450**

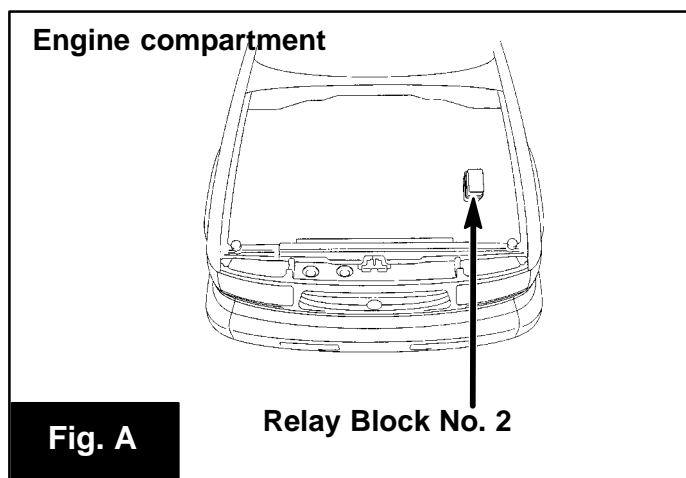
The removed Dome Fuse (10A) is stored in the Relay Block No. 2 Cover in the engine compartment as shown in Figure A.

To minimize battery discharge during transportation and storage the Dome Fuse has been removed at the assembly plant.

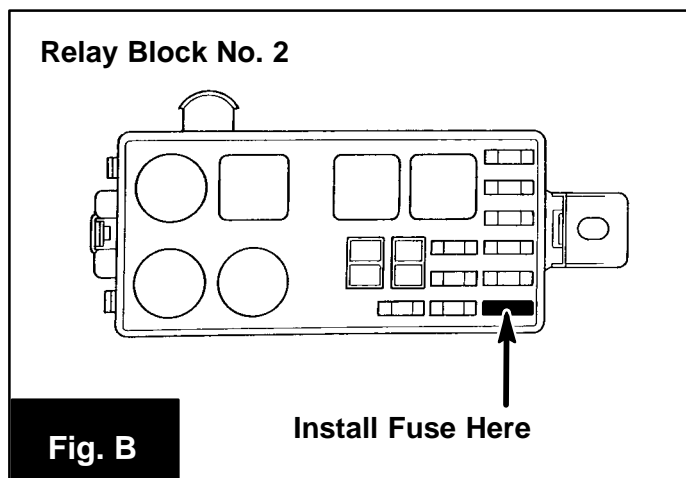
Please install the Dome Fuse in the correct position during Pre-Delivery Service (PDS) as shown in Figure B.

NOTE: If the vehicle is stored at the dealership for a long period of time after PDS, please disconnect the negative battery terminal to prevent battery discharge and refer to TSIB EL95-002 for battery maintenance information.
